OMI OPERATIONS STATUS

Jacques Claas
Instrument Operations Team
KNMI
The Netherlands

MOWG
12 September 2006
Boulder

FMM anomaly: overview

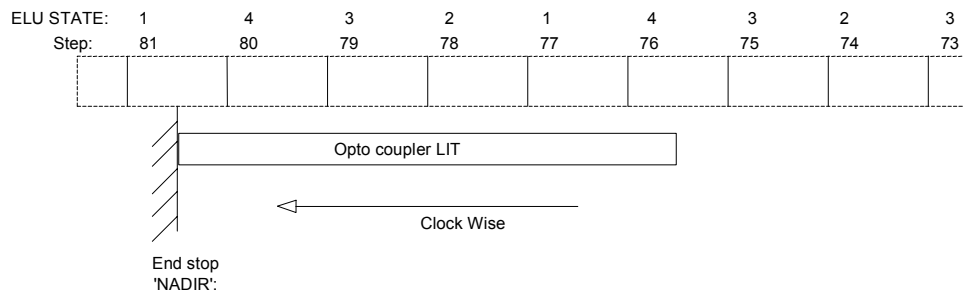
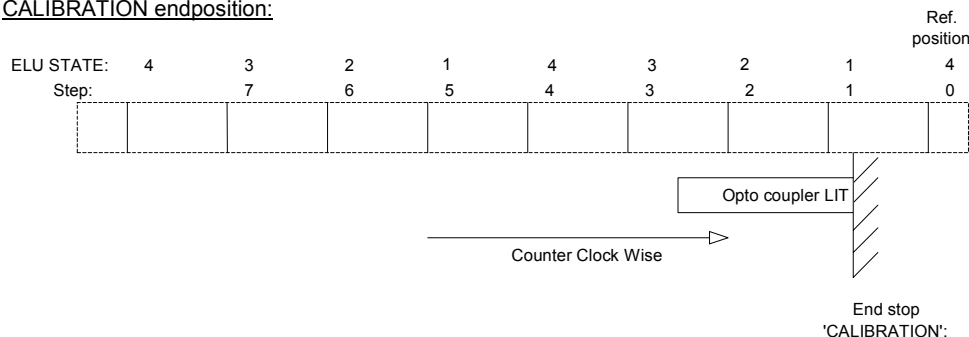
- Till Feb 19th the FMM always bounced against the calibration endstop when moving to the calibration position.
- Between Feb 19th and Feb 28th the FMM not always bounced.
- On Feb 28th, when moving the FMM into calibration position for a LED calibration measurement, the opto-coupler status remained “dark” even after the 4 additional steps.
- Automatically a Fault Management procedure started, resulting in a transition to Idle mode which effectively stopped the generation of science data.
- As part of the Fault Management procedure, the FMM was moved to nadir position.

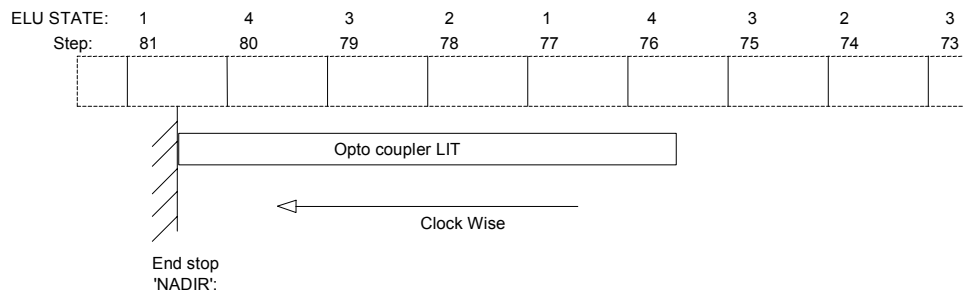
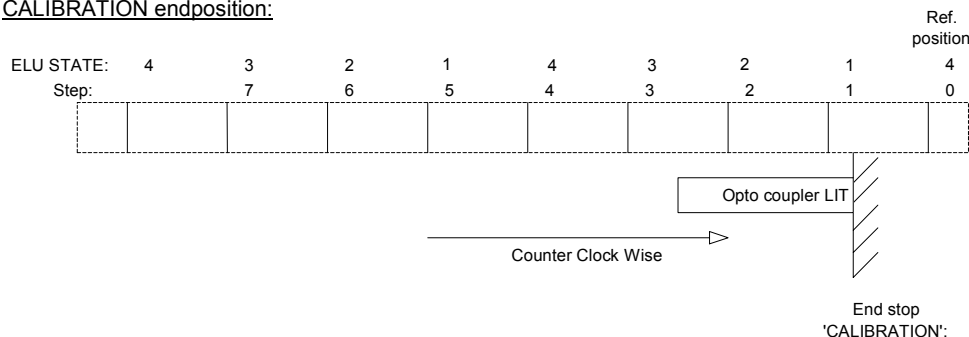
- **Tests 1-3:**
Find out if the FMM can be moved around its nadir position?
- **Tests 4-5:**
Find out if the redundant FMM coils can be used, also in combination with the nominal FMM coils (double drive torque!)
- **Tests 6-8:**
Find out if the FMM can be moved from the nadir position 79 to position 2 without losing steps in between due to mechanical/electrical wear.
- **Tests 9-10:**
Find out if there is mechanical/electrical wear or opto-coupler problem at position 1.
- **Tests 11 (without WLS) – 12 (with WLS):**
Find out if there is mechanical/electrical wear or opto-coupler problem at position 0; find out if bouncing is taking place.
- **Test 13 (with WLS):**
Find out the precise position of the calibration endstop by commanding FMM to virtual position -4; find out when FMM jumps back.

- All tests were successful.
- During all tests the FMM showed nominal behaviour.
- There is no loss of steps when moving the FMM from nadir position to calibration position and vice versa.
- There is no indication for an opto-coupler problem.
- No bouncing against the calibration endstop takes place when commanding the FMM step-by-step.
- When using the WLS, the WLS signal is highest at FMM position 1 whereas position 0 (the calibration position) was expected.
- It turns out that the FMM position during a calibration measurement is just in front of the calibration endstop and not at the calibration endstop.
- A known initial position 79 can be assumed when starting to use the FMM.
